Transport
Canada

Issue 3/2011

Feedback

Canadian Aviation Service Difficulty Reports

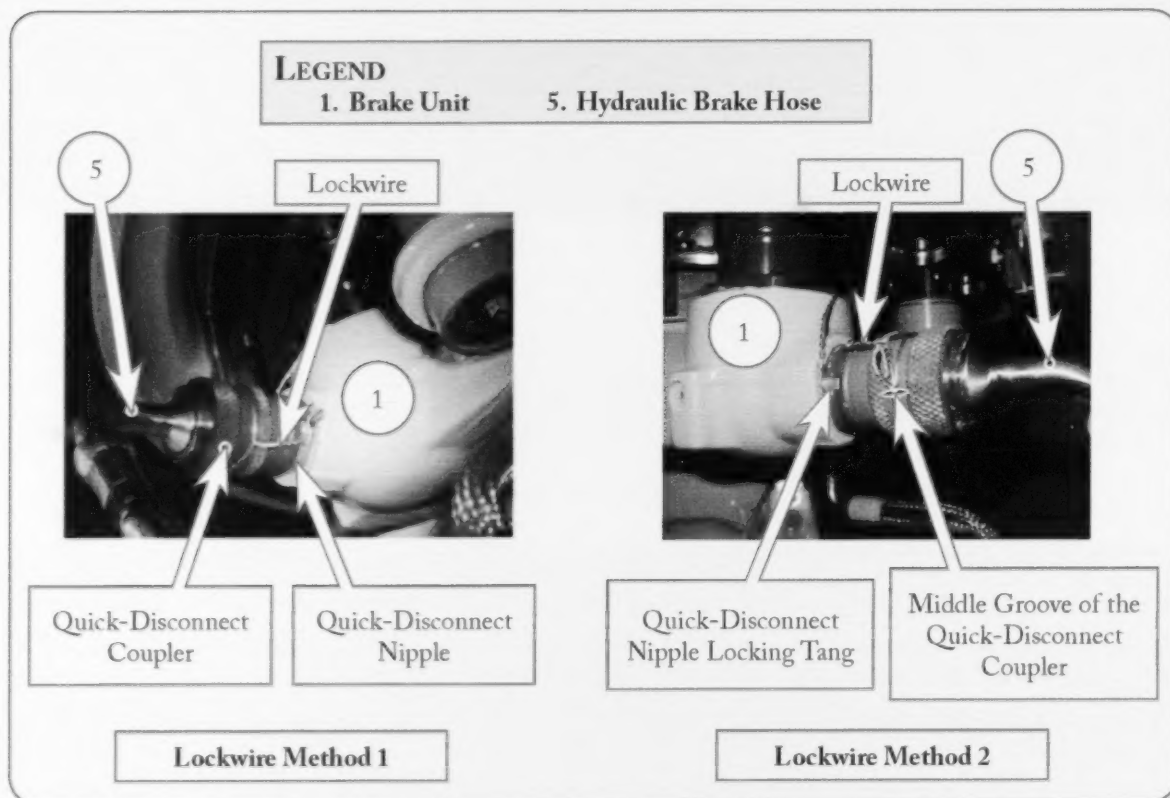
- 3 cases of brake quick disconnect (QD) fittings found loose which caused a landing with a locked / dragging brake. The loose QD allowed hydraulic pressure to be trapped within the brake causing it to remain locked on landing.
- 1 case where 2 QD fittings were found loose, causing the landing with no braking ability on the same gear.
- 3 potential cases where the QD fittings were found disconnected on the production line.

- Cleaning of the brakes could have lead to inadvertent disengagement of the QD locking tang subsequently leading to QD backing off (getting loose).
- QD was not connected properly (locking tang not engaged) after a brake carrier change.

When compared to the CRJ200/700 design, the CRJ705/900/1000 design is more susceptible to an incorrect installation through the inadvertent disengagement of the locking tangs. *(continued on next page...)*

The following Bombardier Aircraft Maintenance Manual (AMM) Temporary Revisions (TR) were released May 2011 which have introduced instructions to utilize 2 methods of lock wire on the brake QD for the CRJ705/900/1000. The addition of the lock wire is to prevent the inadvertent unlocking of the QD.

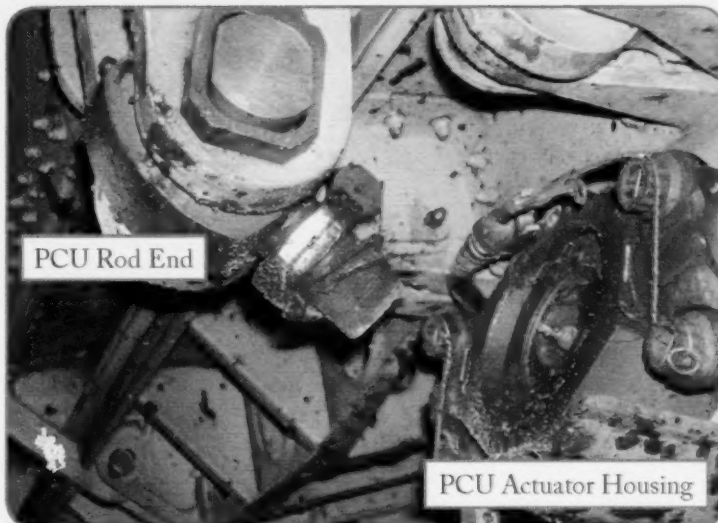
During flight, a R/H spoiler panel began to float freely where maintenance discovered the #2 R/H Spoiler Actuator threaded rod end assembly had failed and separated from its adjoining PCU housing.

The flight spoiler PCU actuator was replaced, MEL removed and the aeroplane was made serviceable.

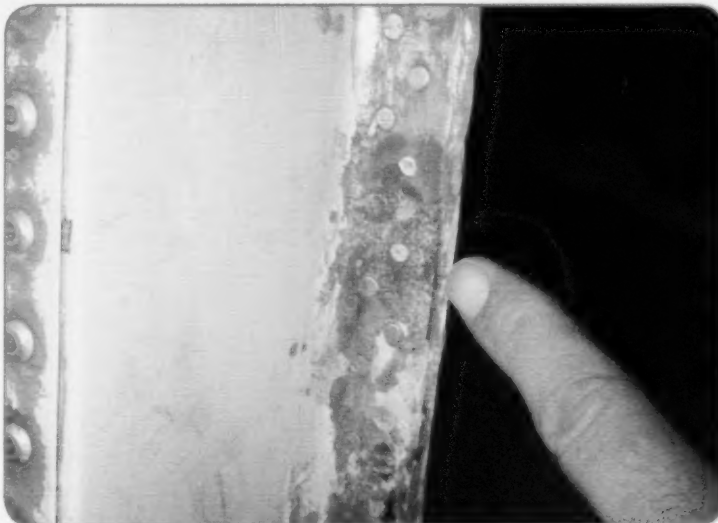
The aeroplane passenger door seal had a small tear in it causing a pressurization leak. Upon maintenance inspection when the door seal was removed, corrosion was noted.

A further inspection found extensive corrosion through the skin with a width of 2.5 cm (1 in) by 1.27 cm (1/2 in) on the top of the door seal retainer under the seal.

A repair was carried out, the corrosion removed and the aircraft was made serviceable.

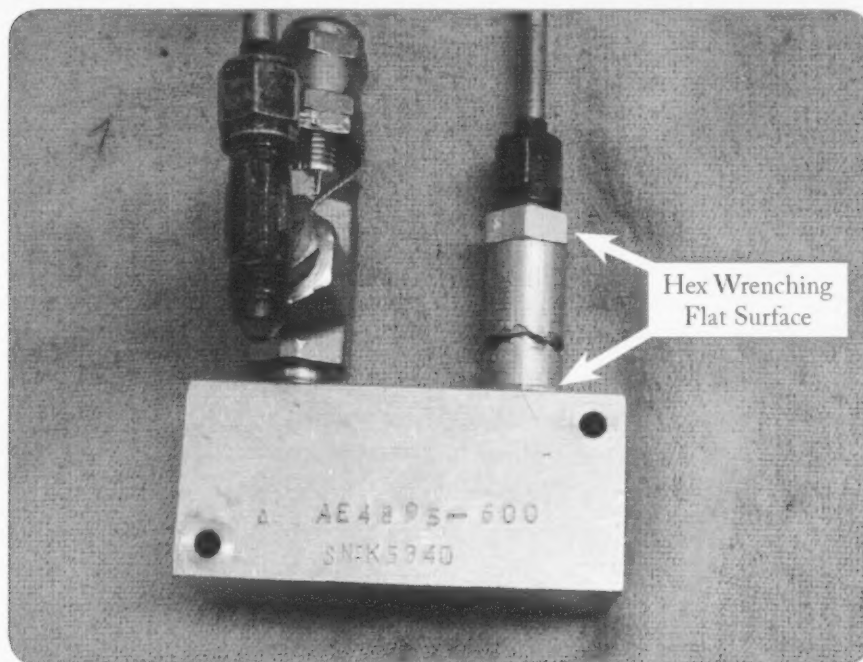
A hydraulic fluid leak was identified when closing the main cargo door. Maintenance investigation identified hydraulic fluid leaking from the cargo door manifold assembly at the check-valve body due to a circumferential and through crack.

It is suspected that the hydraulic line was torque during installation without the use and support of the check-valves Hex wrenching surface, stressing its cylindrical body and causing its failure.

The manifold assembly was replaced, a leak and function check carried out and the aircraft was made serviceable.

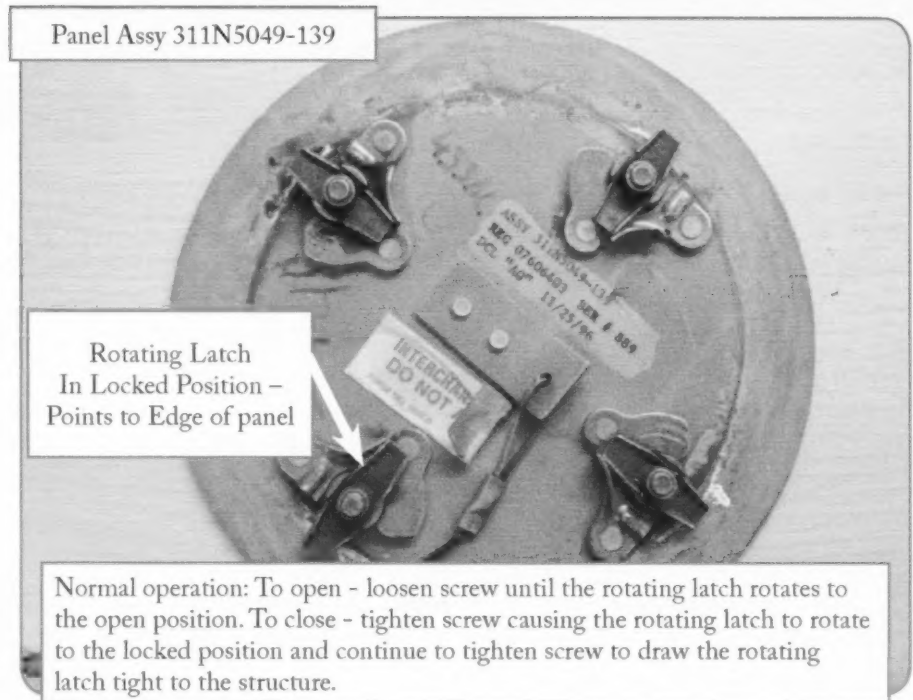
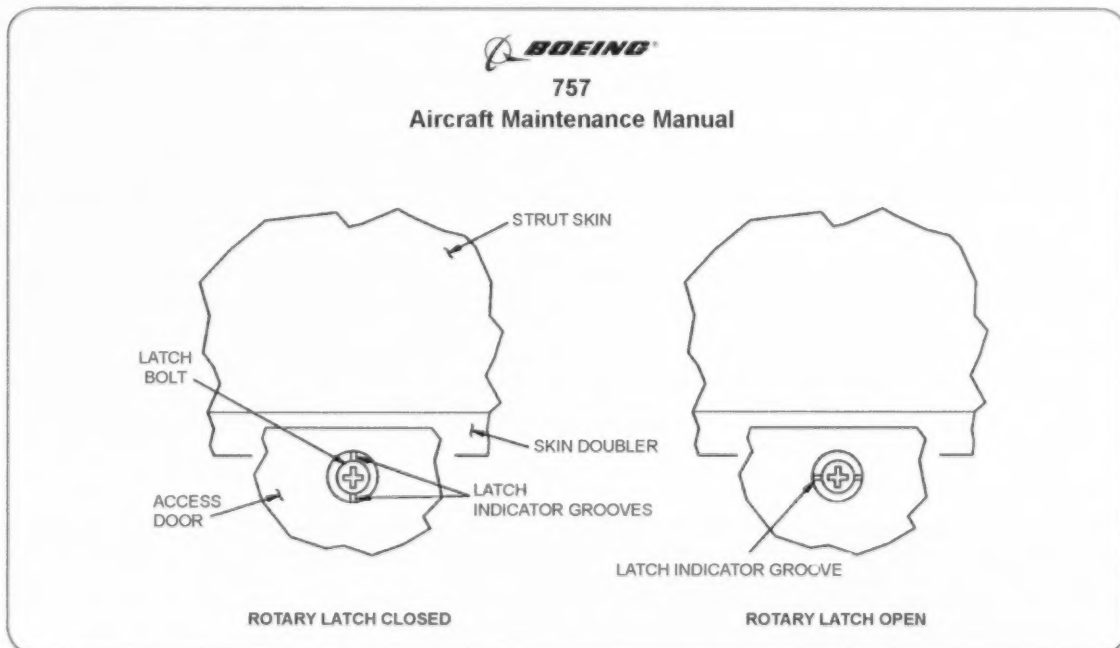
Boeing AMM 54-53-01 defines the correct panel "latch indicator groove" alignment as seen below for a "closed/locked" and "open/unlocked" position.

Also included is a picture of the backside of the panel as seen in the "closed/locked" position. Note that the "groove indicator" marks are a direct indication of the rotating latch position which retains the panel to the pylon structure. ✱

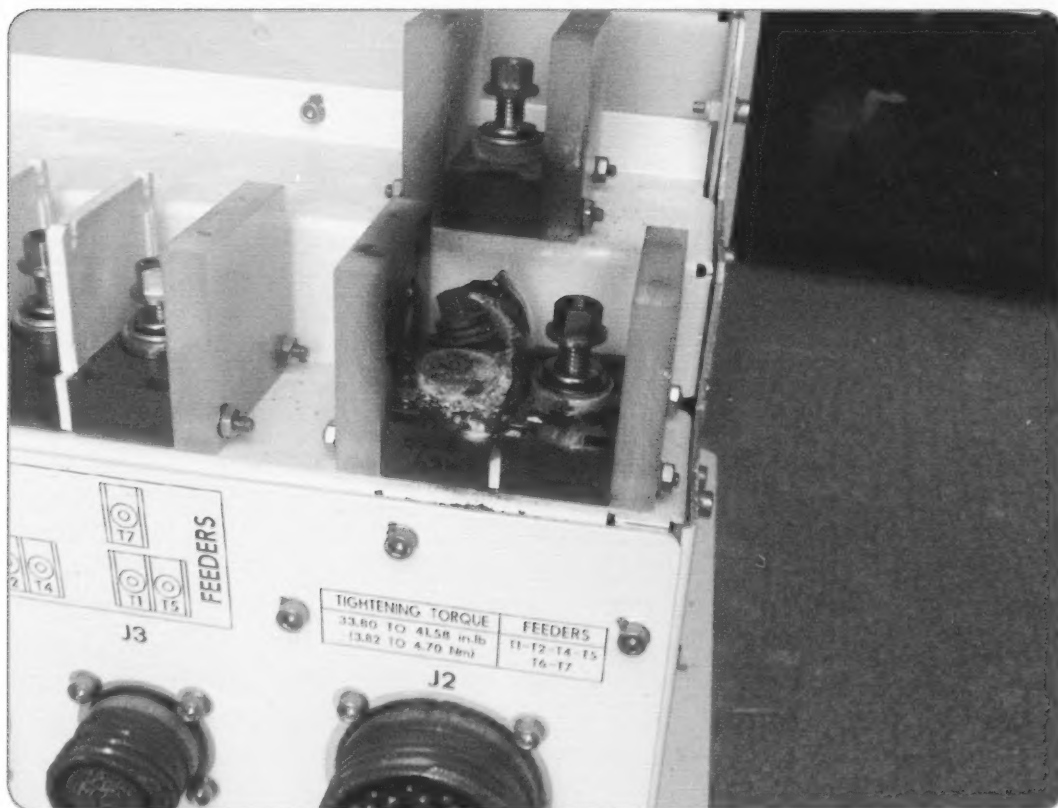
Two bus bars (ESS bus) were confirmed with no power and the battery connections were verified all good. On visual inspection of the L/H Secondary Power Center (SPC), the T1 wire-lead and stud was confirmed as badly burnt and melted.

The SPC was replaced and the aeroplane was made serviceable.

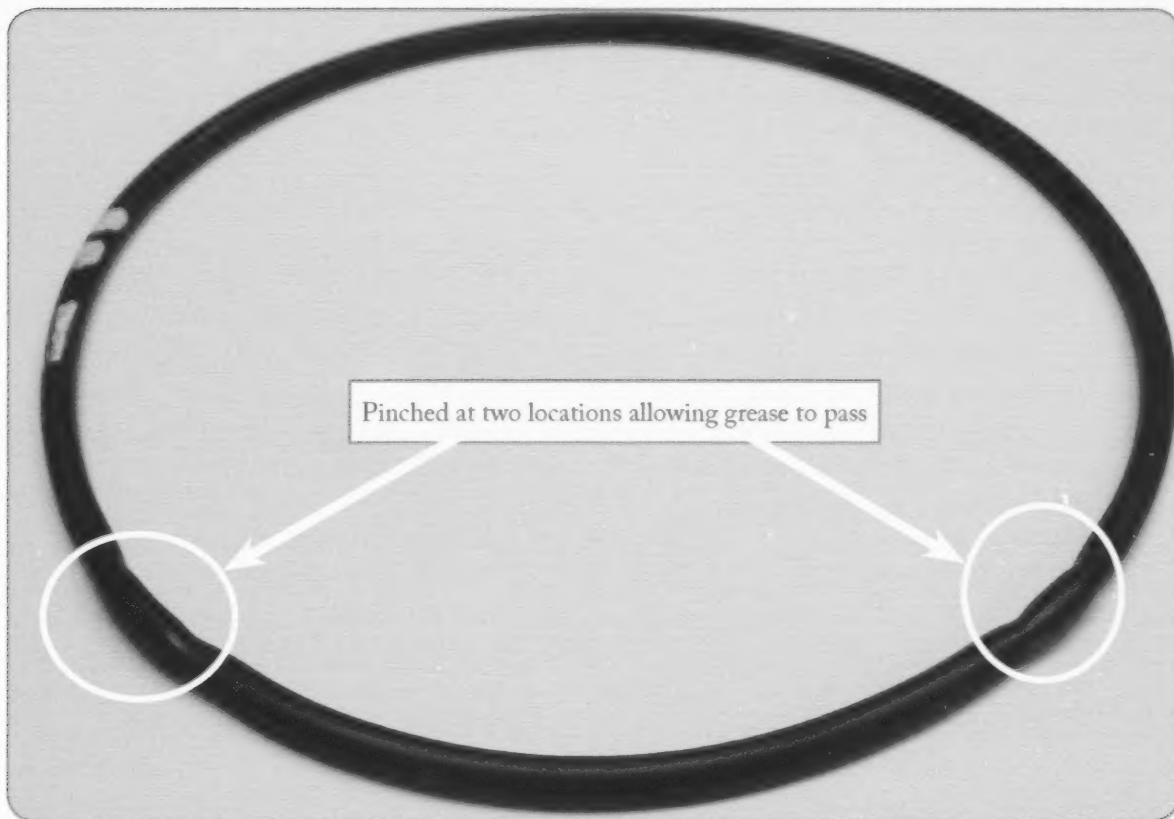
Maintenance investigation revealed that the bearing caps recessed O-ring was improperly installed and found pinched, allowing grease to ingress into the pressurized nose fuselage underfloor area.

The O-ring was replaced and correctly installed; cap reinstalled per AMM and the aeroplane was made serviceable.

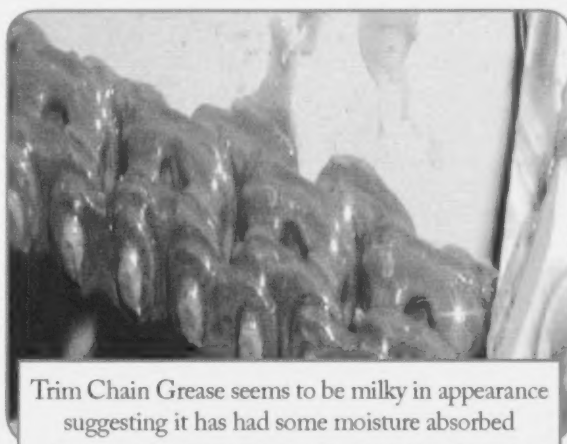
Trim Chain Grease seems to be milky in appearance suggesting it has had some moisture absorbed

Prior to this flight, the aeroplane had been parked outside in heavy rain, which may have resulted in a buildup of water in the screw jack actuator cavity. By the time the aeroplane reached cruising altitude, ice had formed and restricted elevator trim movement. It appears that ice had clogged the trim actuator chain links preventing trim movement. Additionally, one of the tail plane access holes was not properly sealed thus permitting water to migrate into this area.

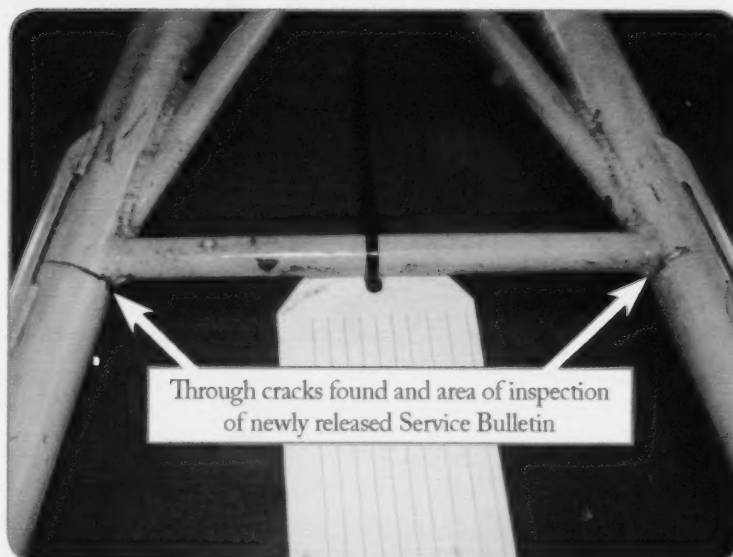
Upon a routine servicing, maintenance found the L/H lower engine mount tubular frame to be cracked through on both of the inboard and outboard areas. The engine mount was removed and sent for repair.

TCCA would like to advise all operators that M7 Aerospace have recently issued Service Bulletin 226-71-018 for a detailed inspection of the concerned engine mount area. ✖

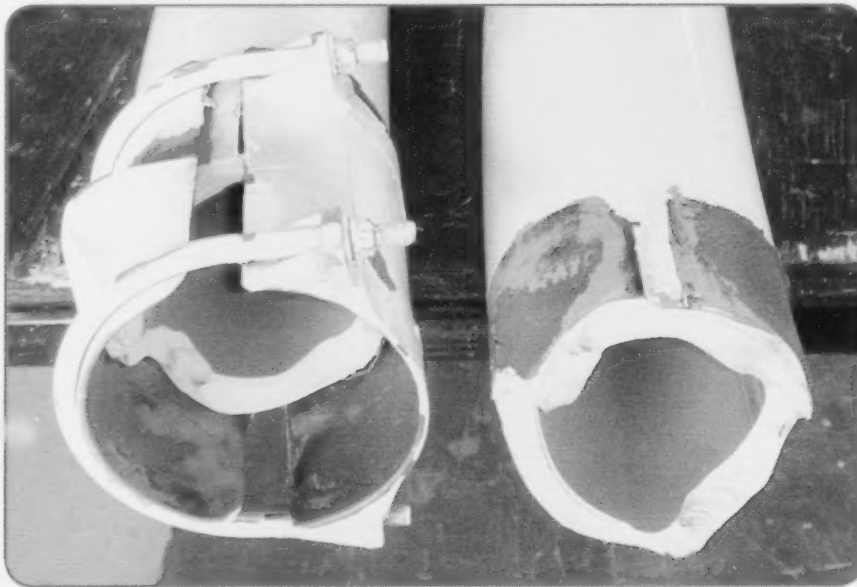
While landing on a heli-ski run, a loud bang was heard and there was some slight settling on the right rear side of the helicopter. Inspection by heli-ski guide found no indications so operations continued. Post flight inspection by an AME found the aft landing gear crosstube cracked.

Upon removal, the crosstube was found broken through under the saddle. The crack is believed to have progressed from a small corrosion pit.
